# **Cavitation quality of turbine parts - Francis**

A 17 MW horizontal-axis Francis turbine has been tested in order to assess the cavitation quality of its crucial parts. Rather moderate differences among runner blades and very high differences among guide vanes have been found. The possible improvement through repair of especially poor guide vanes has been estimated.

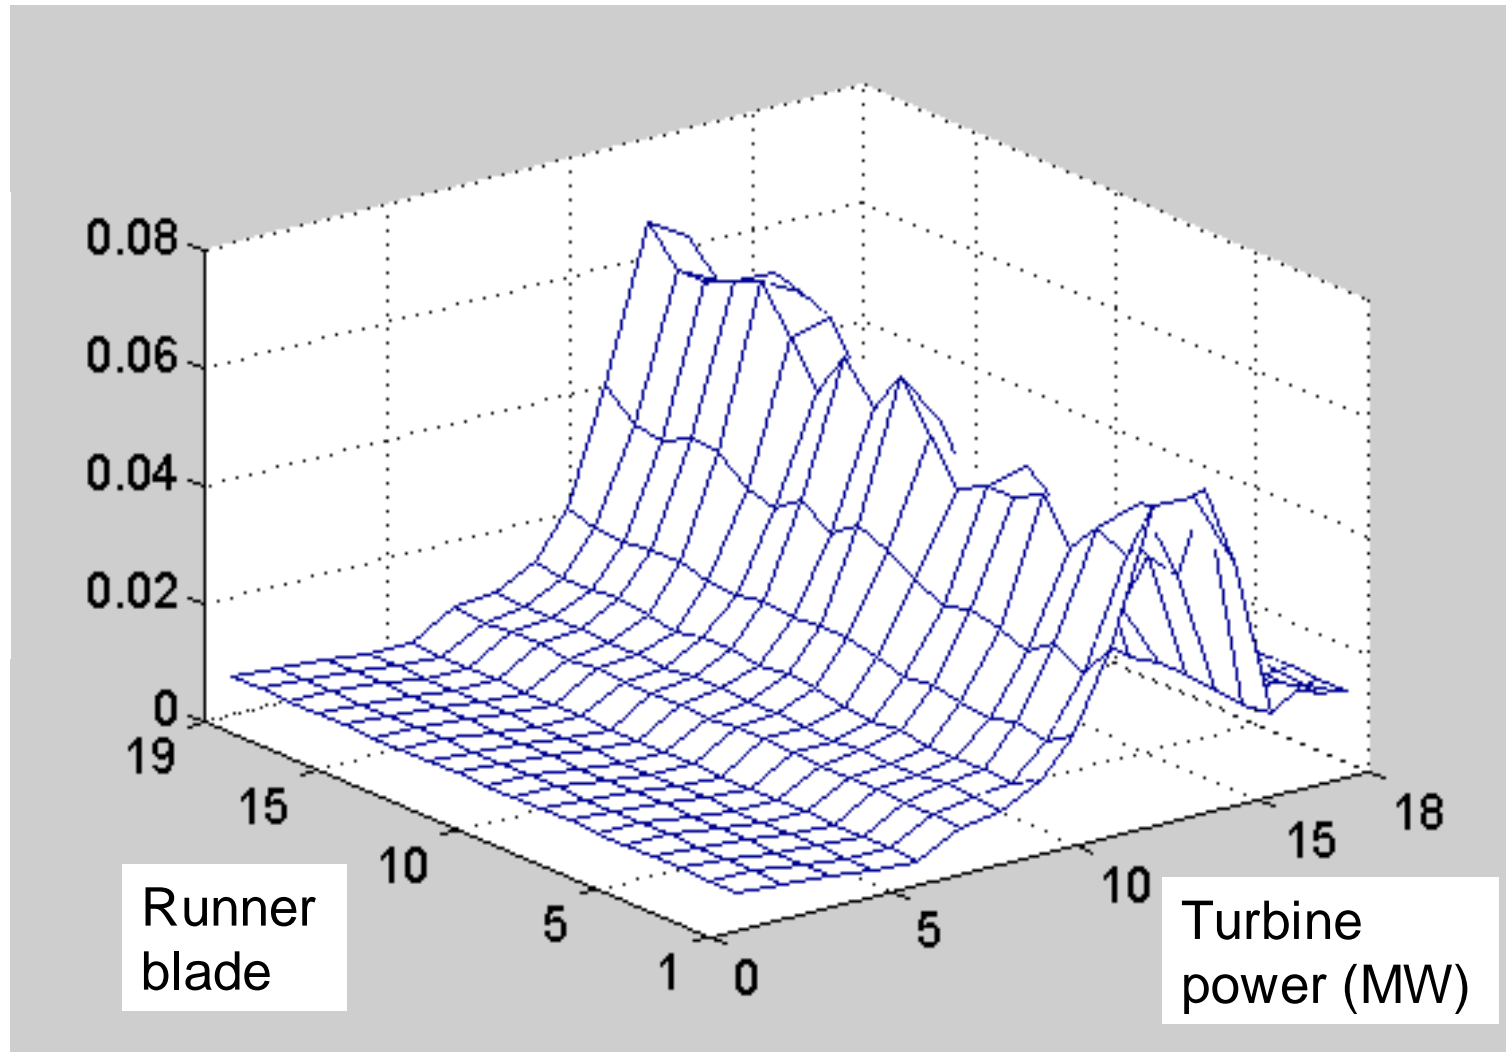
Normalised  
cavitation  
intensity -  
Mean value  
close to  
a runner  
blade

Runner cavitation characteristics:  
The cavitation quality of the  
runner blades is assessed.

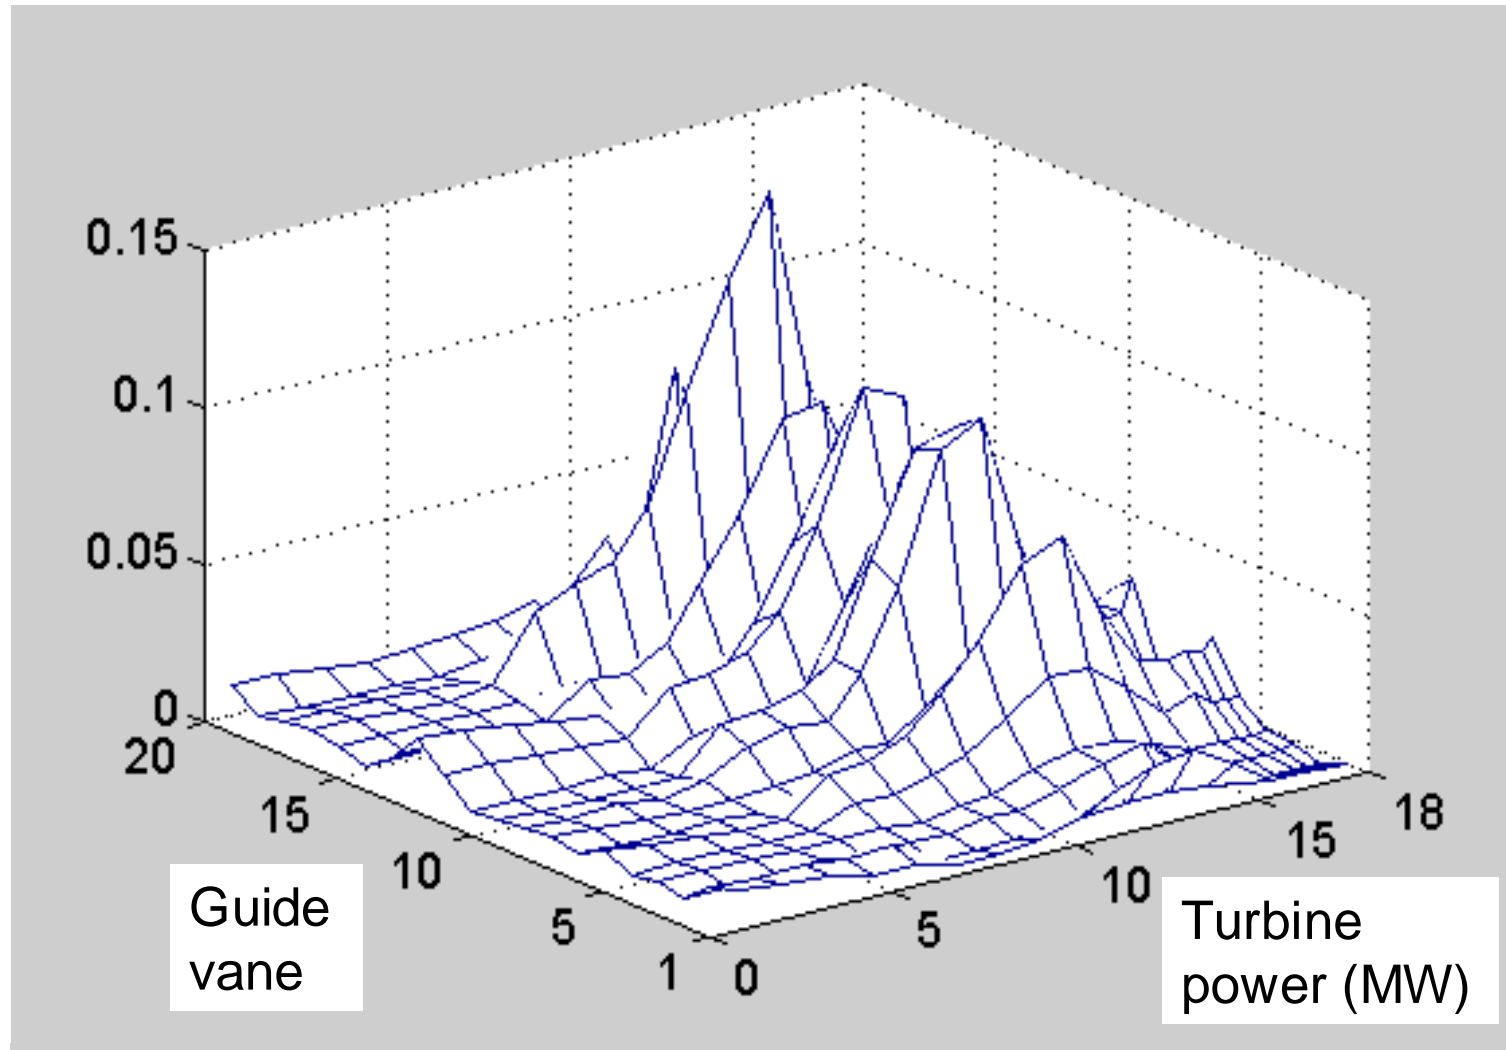
Normalised cavitation intensity - Mean value of that component of cavitation close to the runner blades, which is influenced by a particular guide vane

Wicket gate cavitation characteristics:  
The influence that the guide vanes have on cavitation close to the runner is assessed.

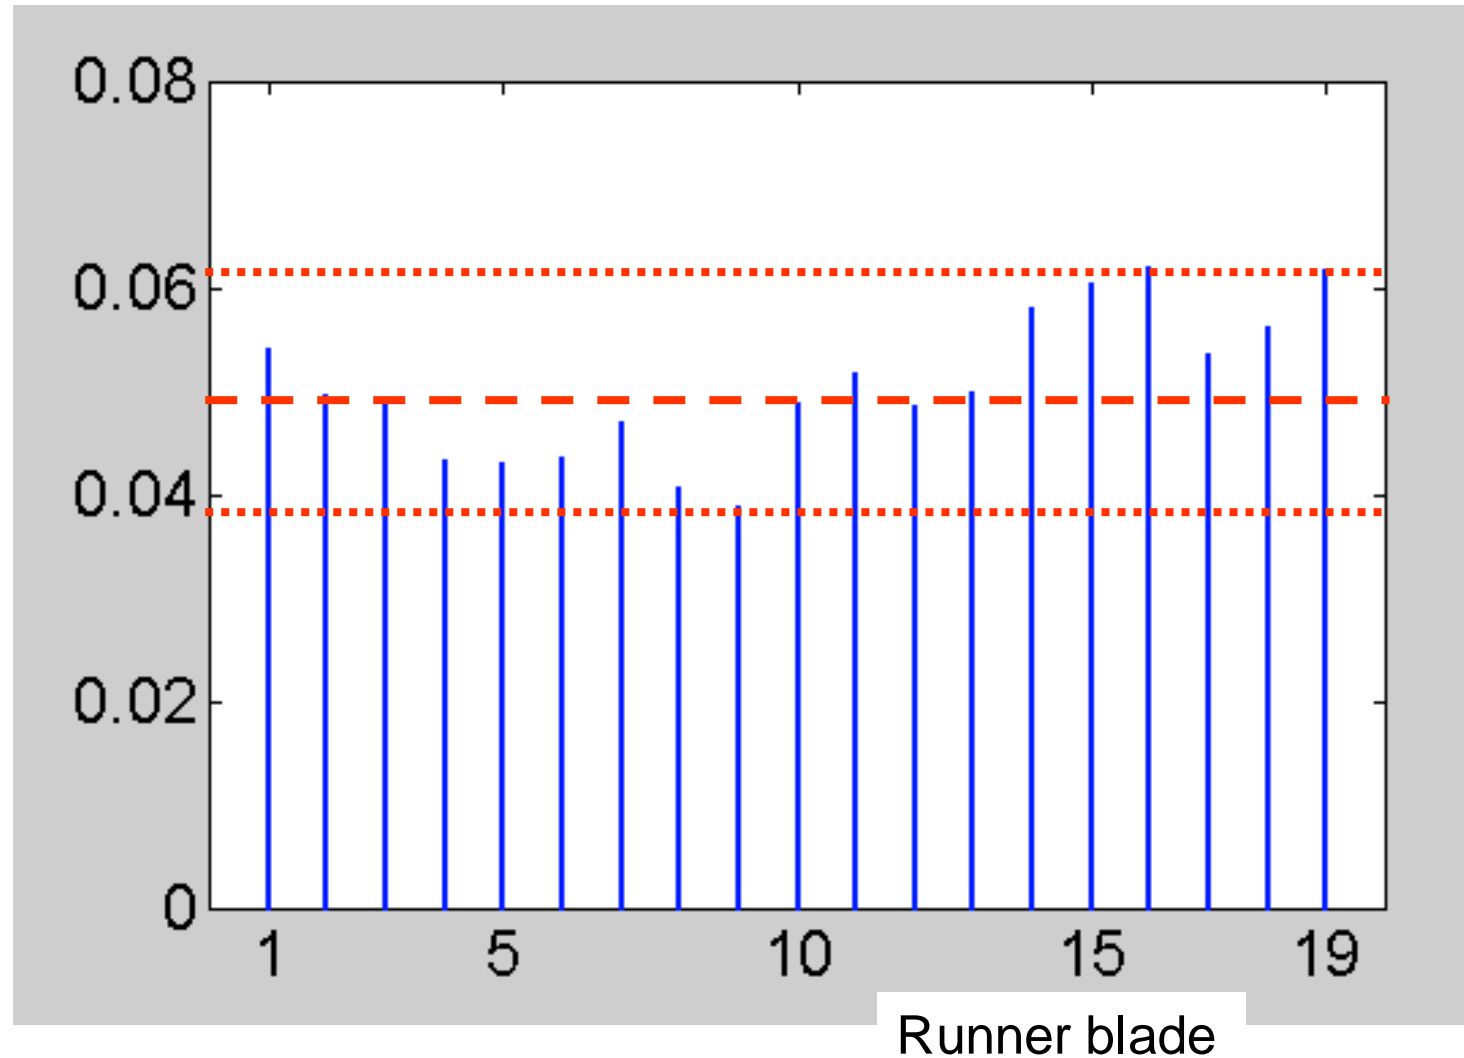
Normalised cavitation intensity at 13.3 MW

Cross-section of the runner cavitation characteristics at the maximum of the total cavitation intensity

Note:  
The quality of the blades varies  $\pm 20\%$ .

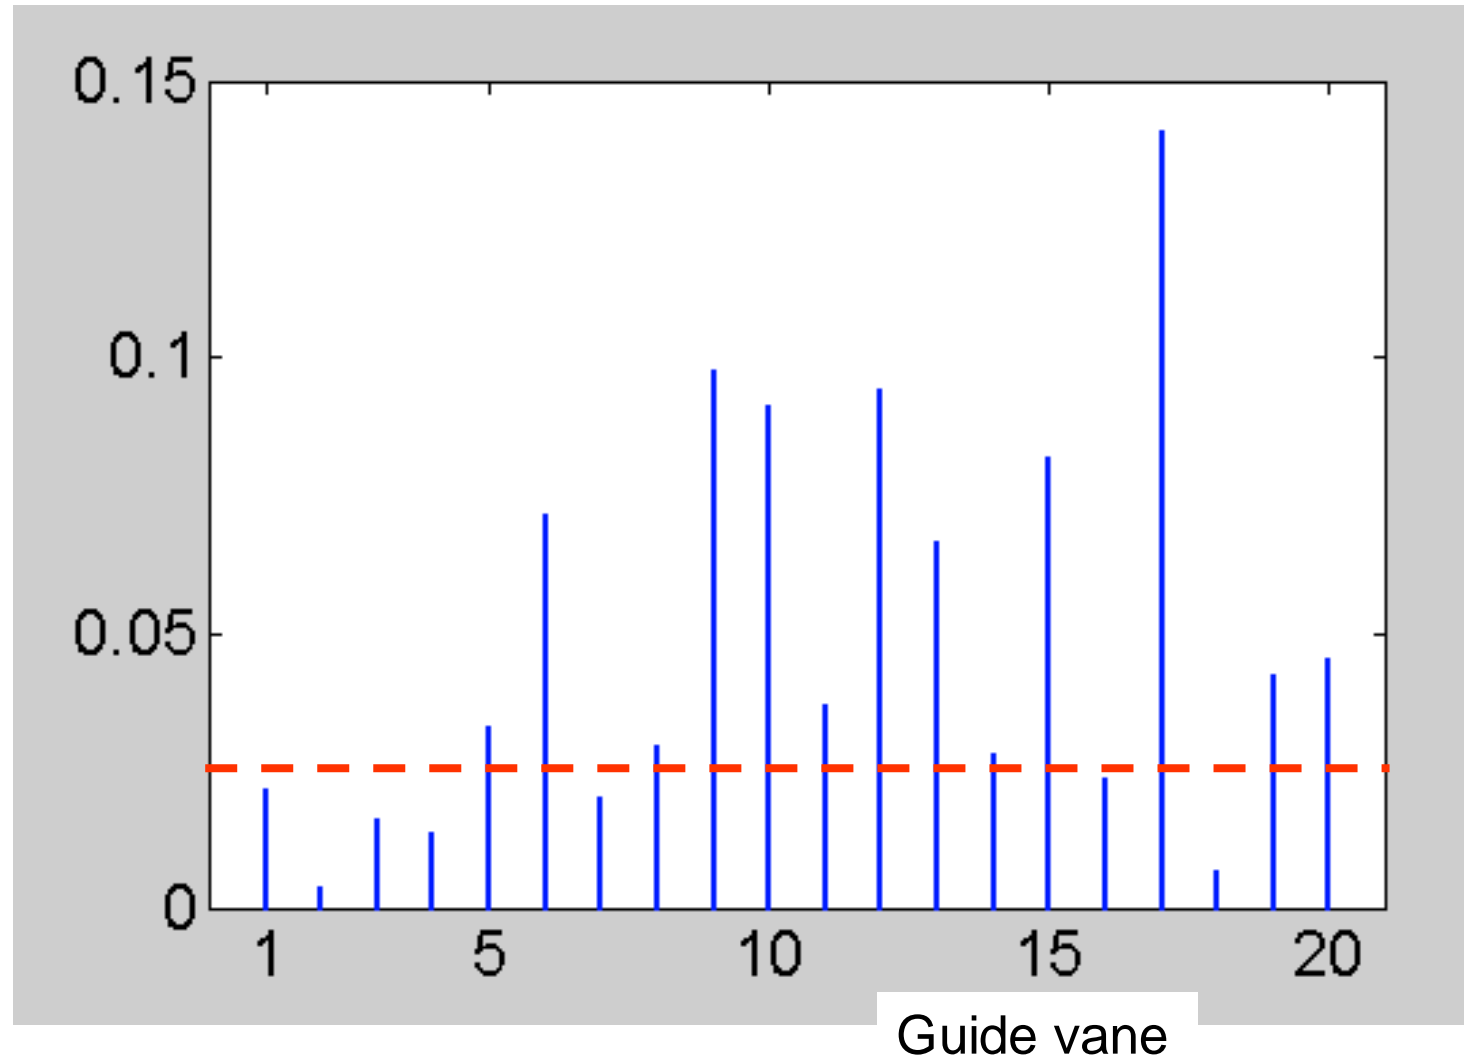
Normalised cavitation intensity at 13.3 MW

Cross-section of the wicket gate cavitation characteristics at the maximum of the total cavitation intensity

Note:  
Some of the guide vanes cause especially strong cavitation.

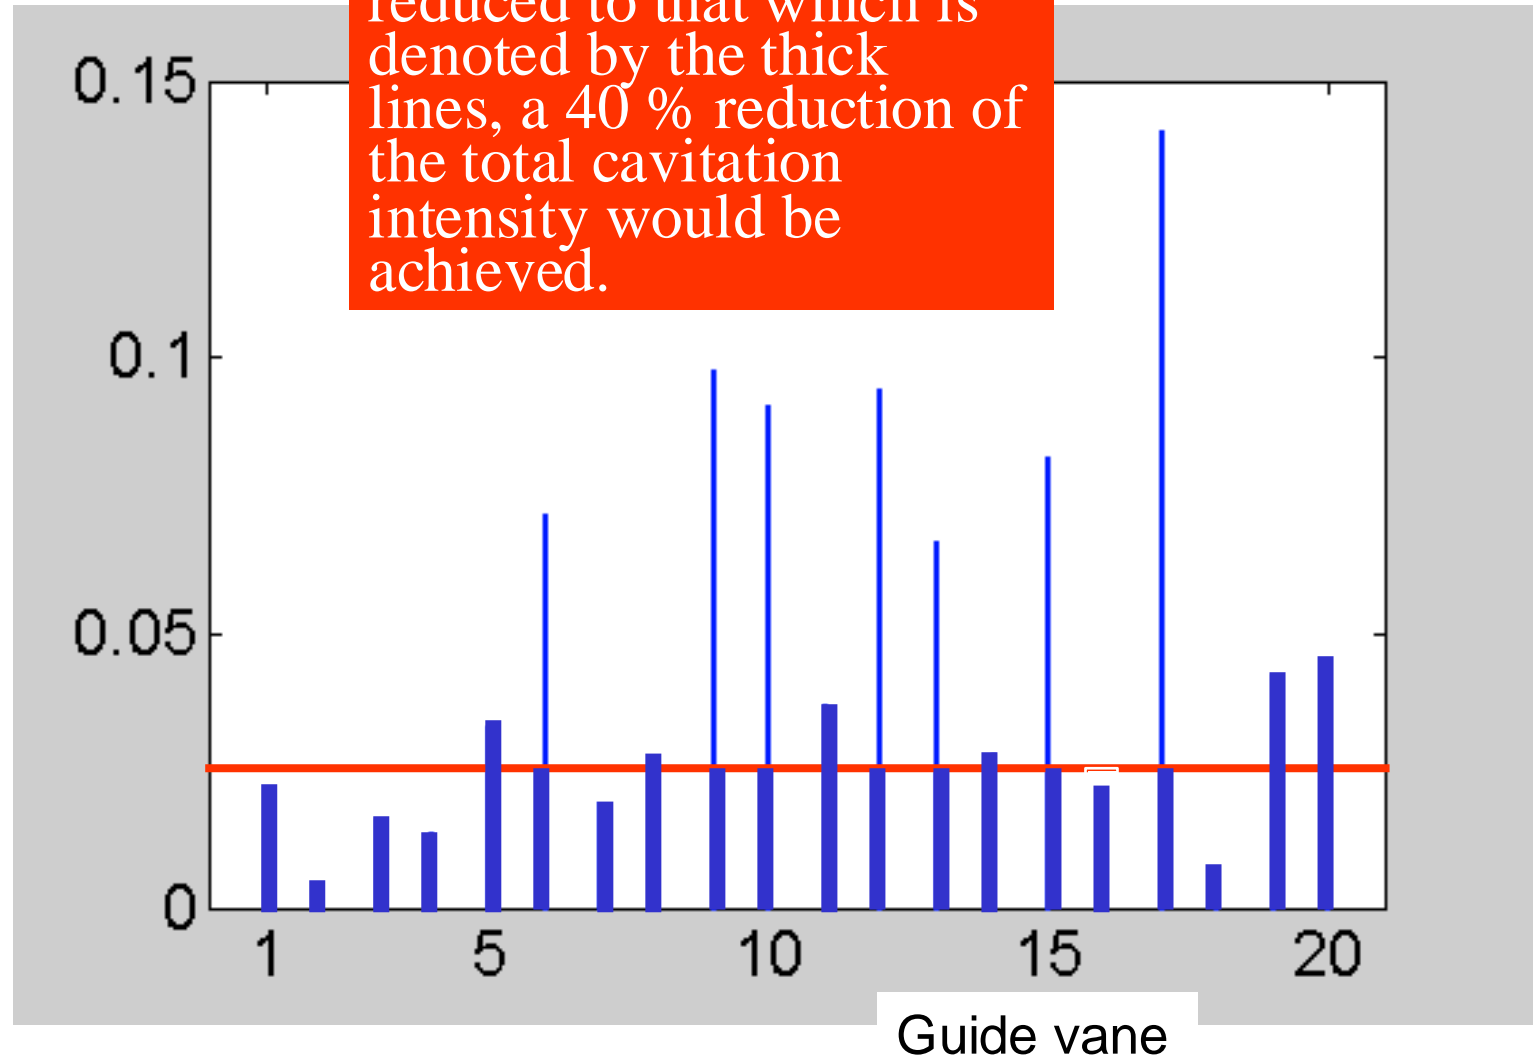
Normalised cavitation intensity at 13.3 MW

If there is any systematic trend in the cavitation quality of the guide vanes, be it related to the differences in the flow in different positions in the spiral or to the differences in the pressure in this horizontal-axis turbine, that trend cannot explain high differences between neighbouring vanes. Here, the cause of the differences has to be looked for in the details of the shape or in the setting differences of each vane.
