# **Improvement assessment - Francis, runner blades**

Six Francis turbines in a plant operating at a 120 m head were updated from 36 to 48 MW.

In a multidimensional diagnostic test of cavitation, the modified runner and one original runner were compared in order to check the success of the modification.

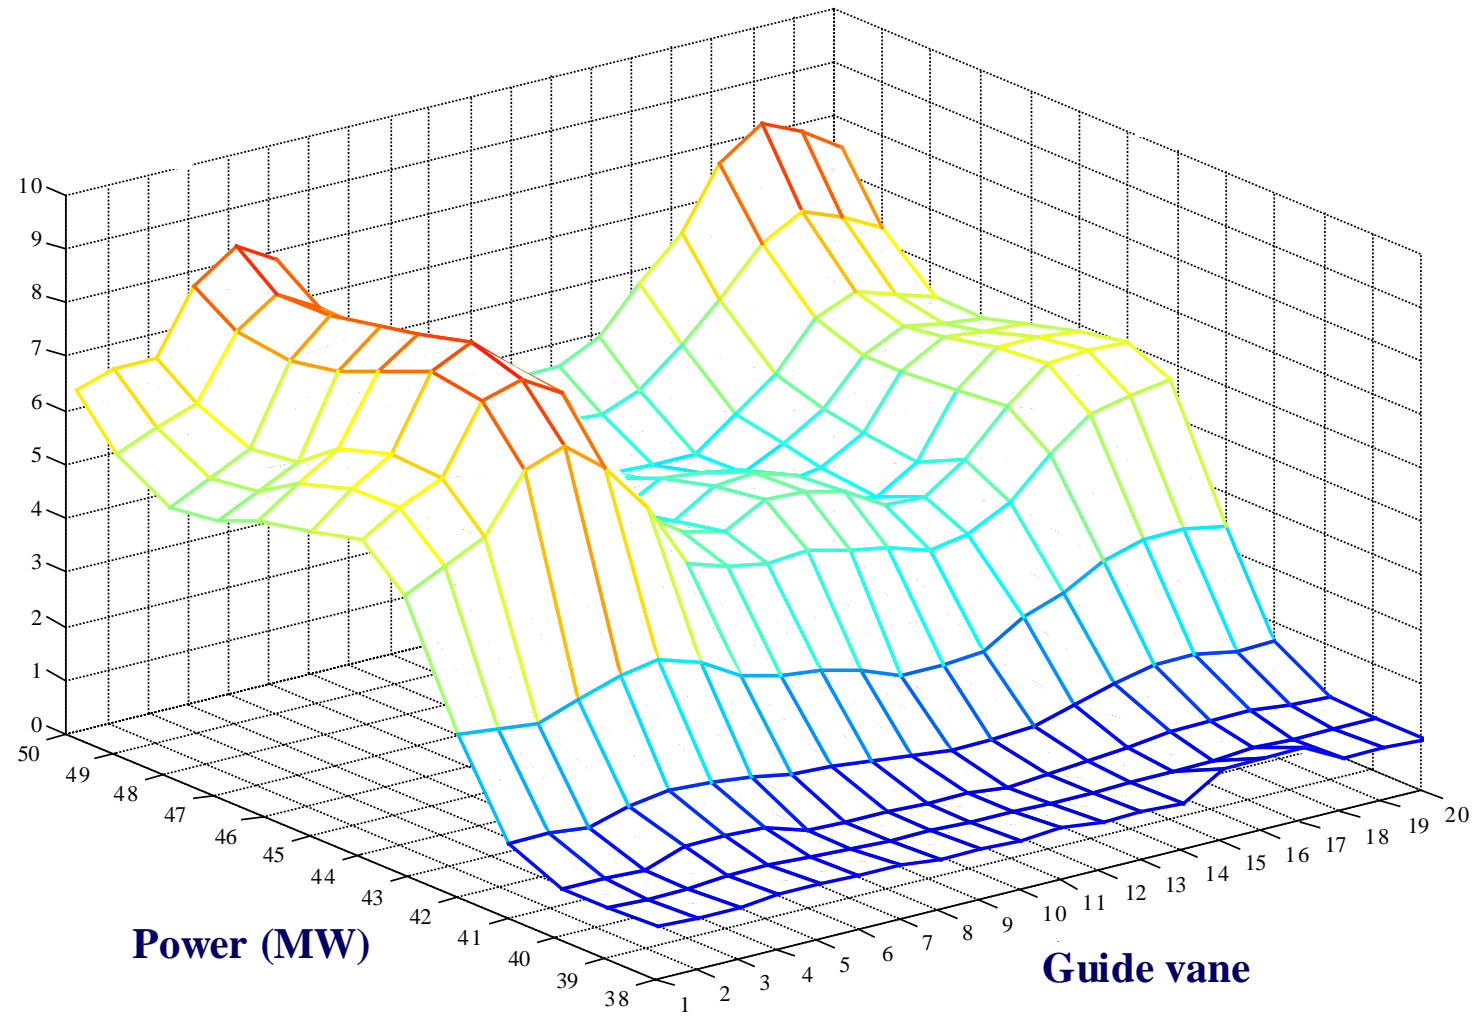
Wicket-gate cavitation characteristic:  
**Original runner**

Component of the cavitation intensity influenced by a guide vane (% of the total)

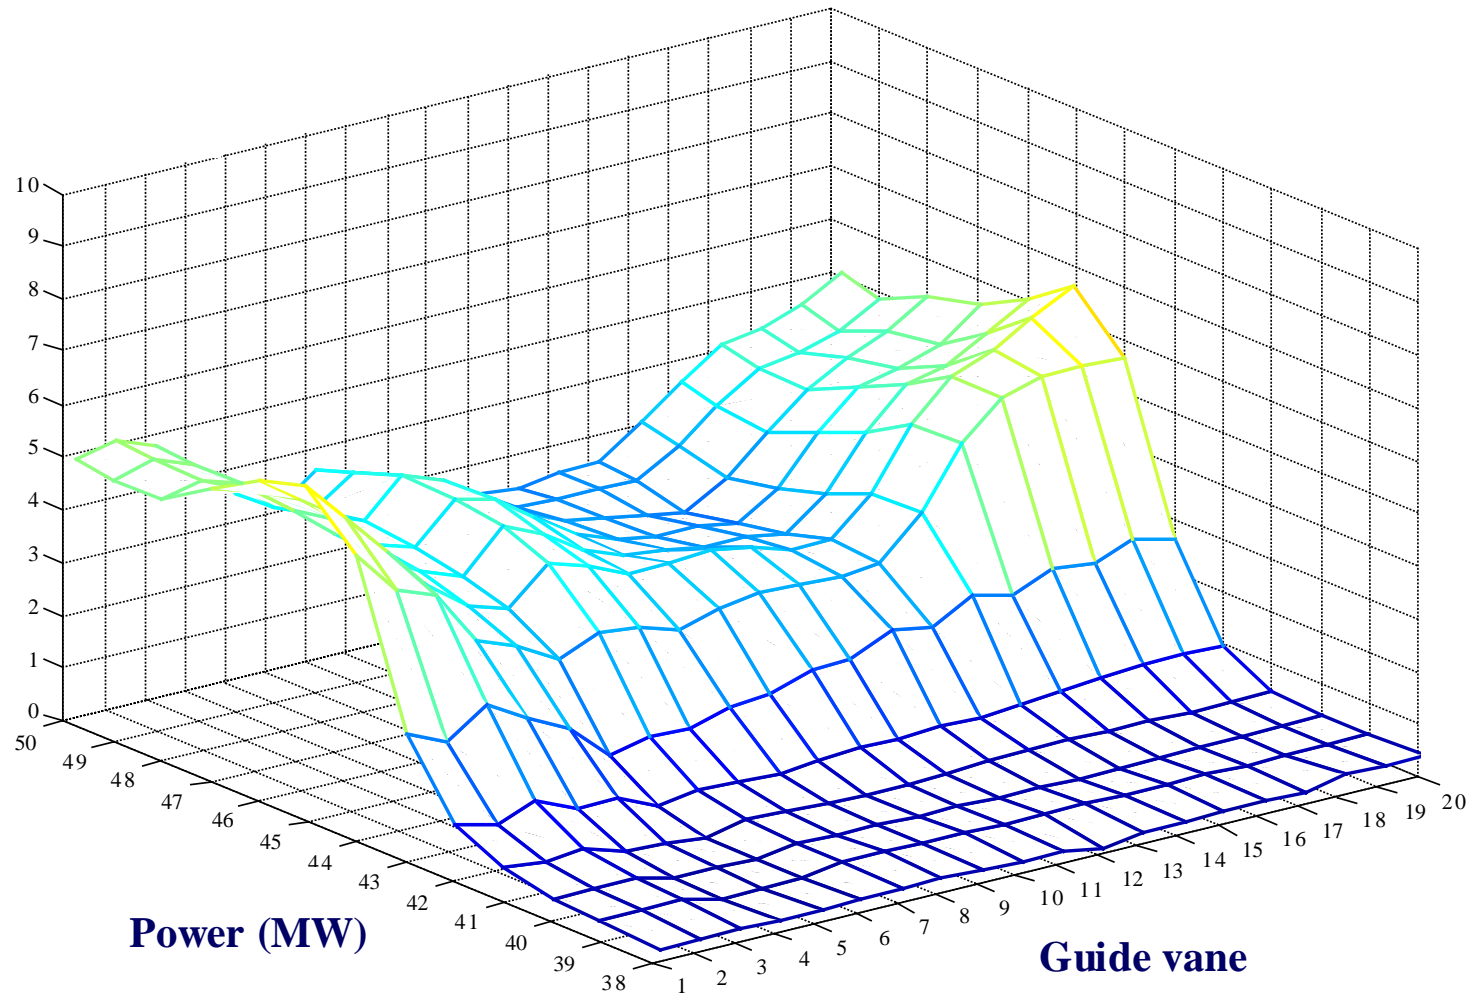
Wicket-gate cavitation characteristic:  
**Modified runner**

Component of the cavitation intensity influenced by a guide vane (% of the total)

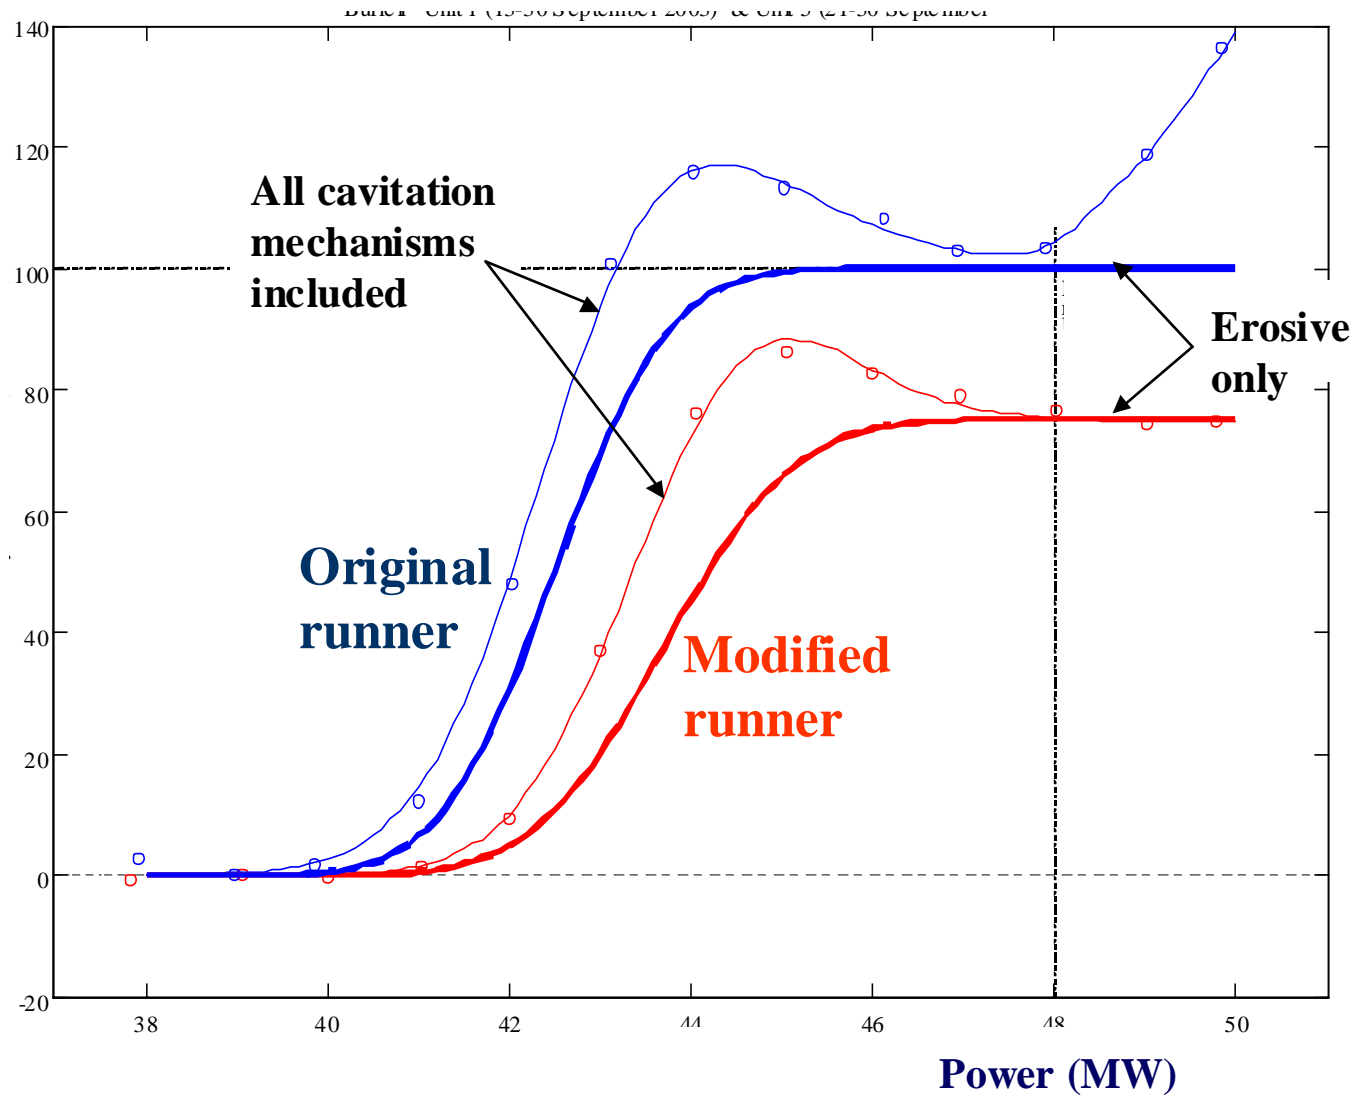
Global cavitation characteristic

Total cavitation intensity on the runner (%)

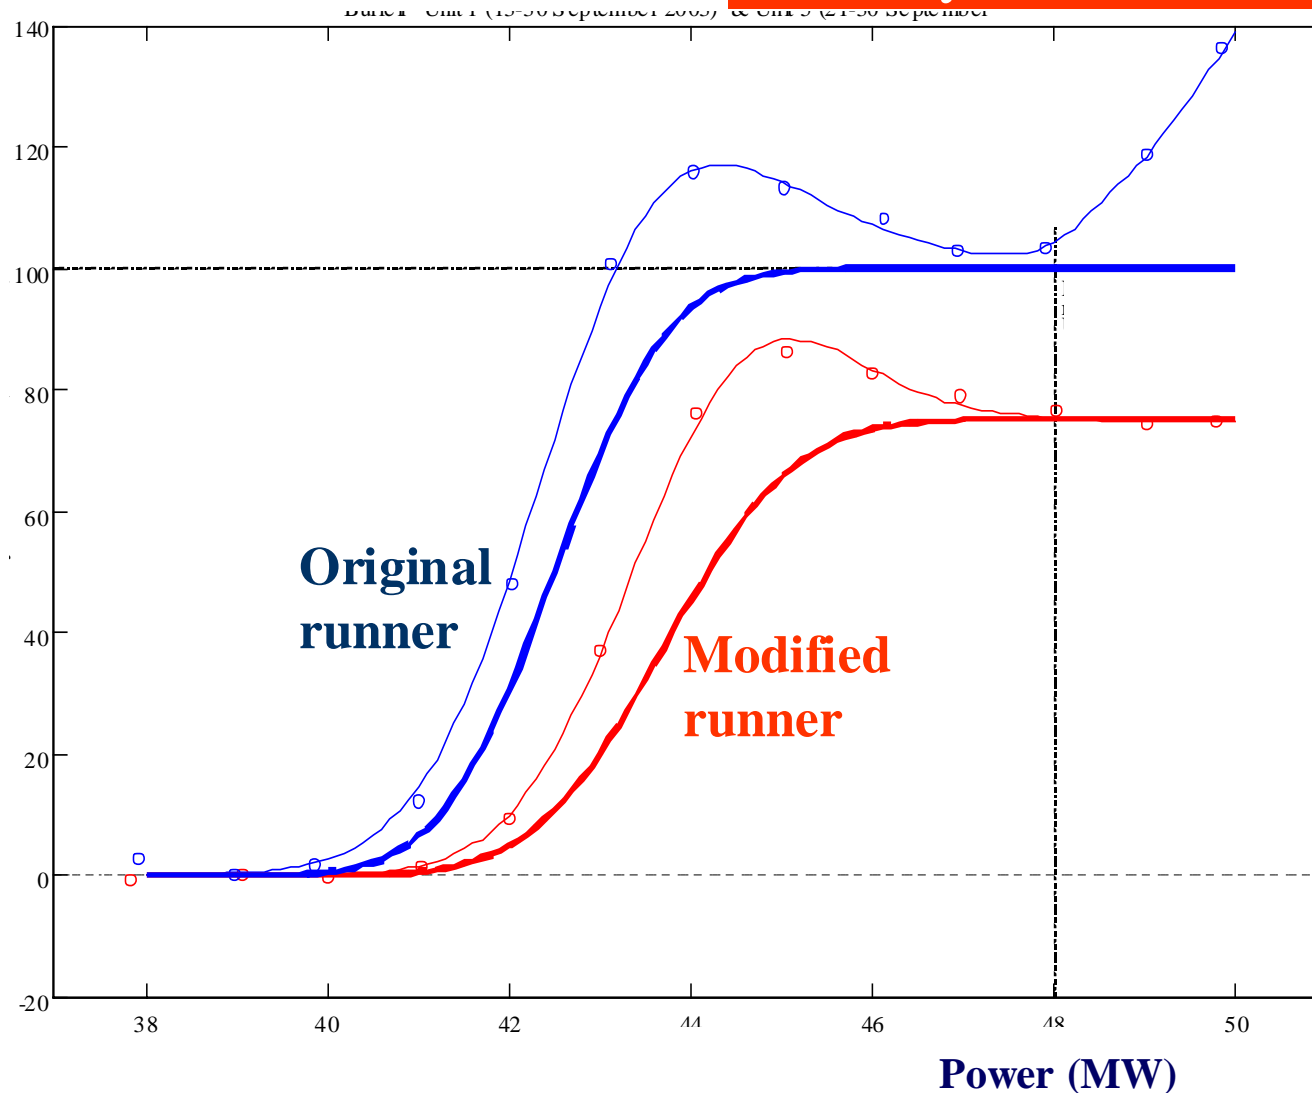
Cavitation not eliminated  
Critical power 1 MW higher  
Intensity 25 % lower

Total cavitation intensity on the runner (%)
