Improvement assessment - Francis, guide vanes

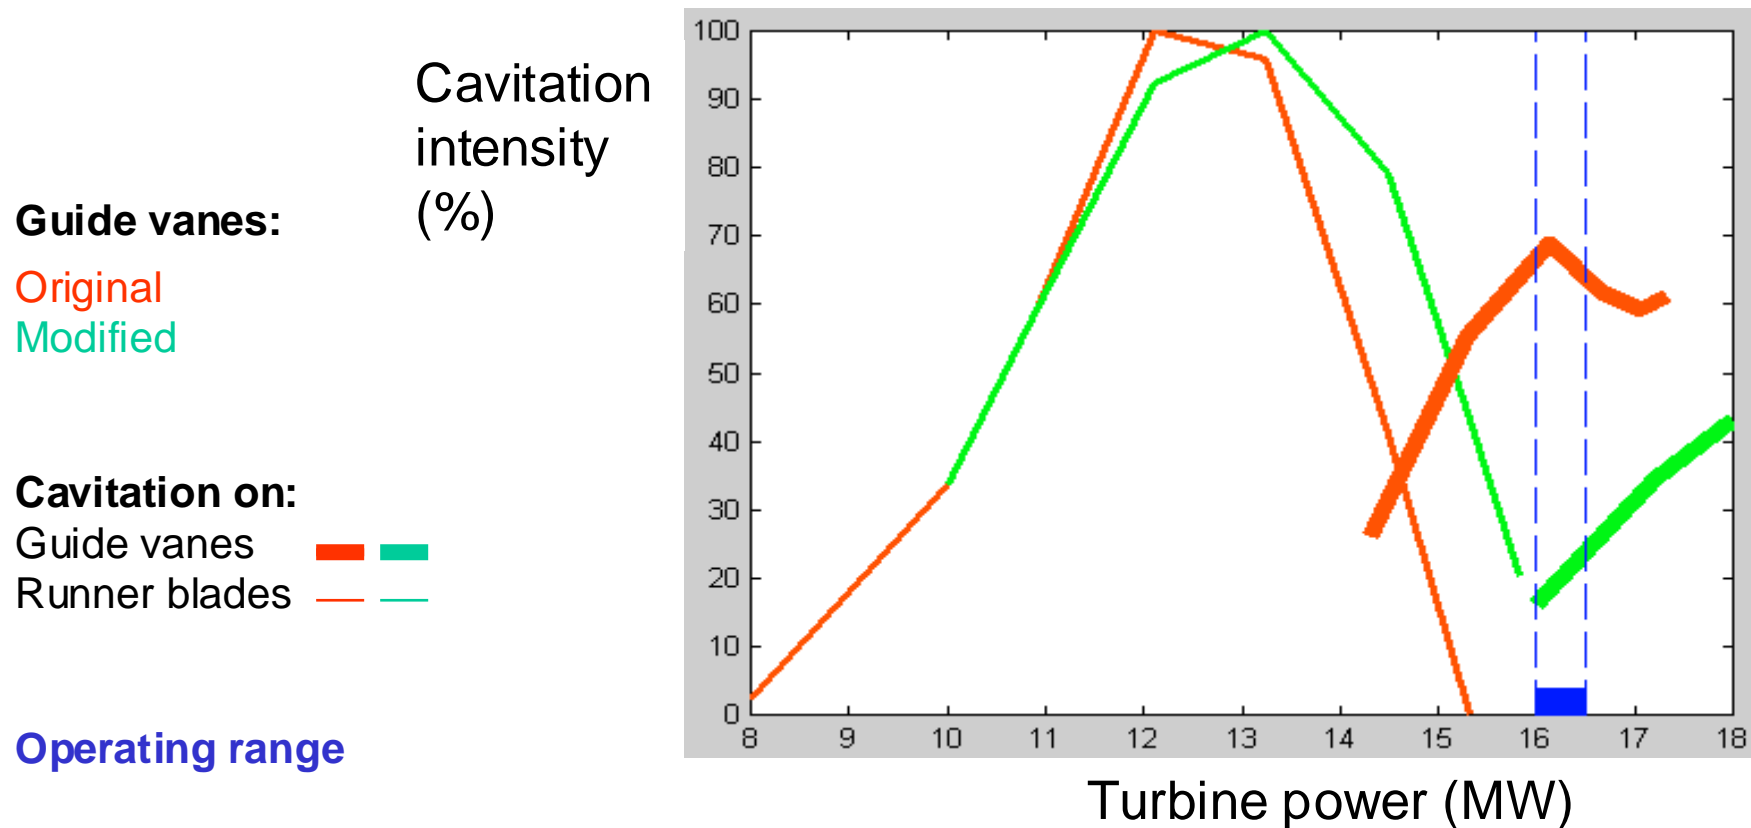
In a Francis turbine of older design, there was cavitation on the guide vanes.

Within the operating range, cavitation on the guide vanes was suppressed by more than three times. The accompanying change in the runner cavitation has no practical relevance.

In order to correct this, the guide vanes were modified.
